## UAS Inspection Report

| A. General Information | |
|---|---|
| Purpose | Image data collection for 100% facade inspection |

Block XX Pioneer XXXXXXXX

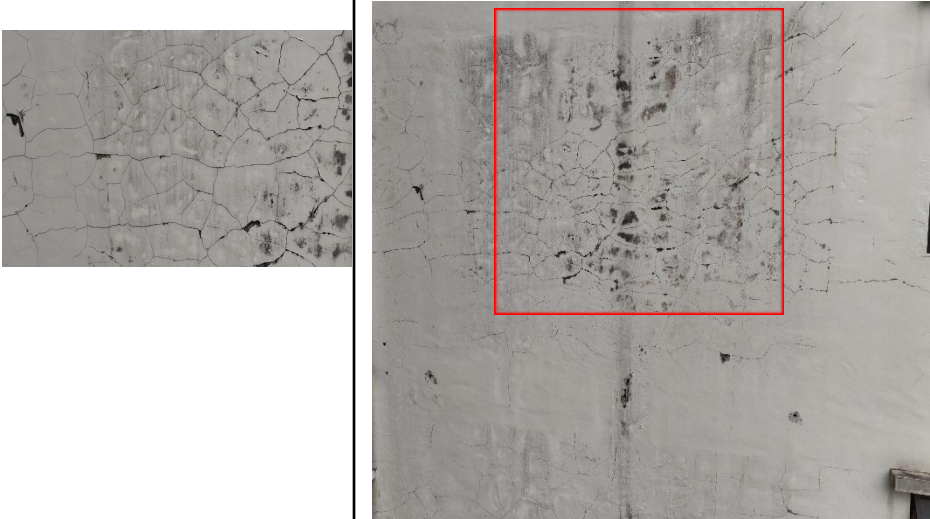
| S/<br>N | Elevation | Image Identification Number<br>and Location | Location | Description of defect(s) (indicate extent and severity) |
|---|---|---|---|---|
| 1 | Elevation A1 | DJI_20260621125932_0002_V | Brick<br>wall | <p>Creased and cracked walls with watermarks<br/>A. Require repair</p> |

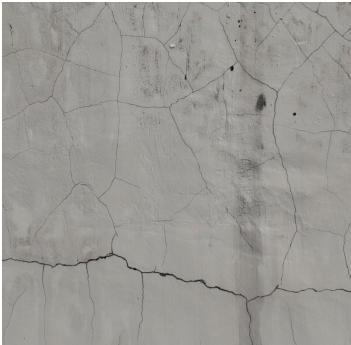
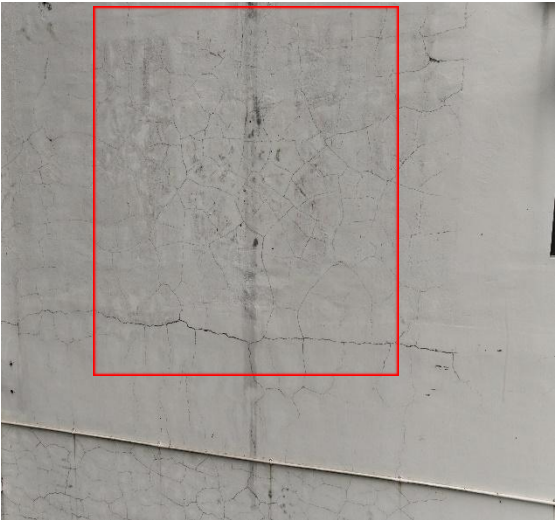
| 2 | Elevation A1 | DJI_20260621125942_0003_V | Brick wall | <p>Creased and cracked walls with watermarks<br/>B. Require repair</p> |
